FINAL REPORT

**ACCIDENT
occurred to
FOKKER F27 MK50
registration marks SE-LEZ,
at Catania Airport,
April 30, 2016**

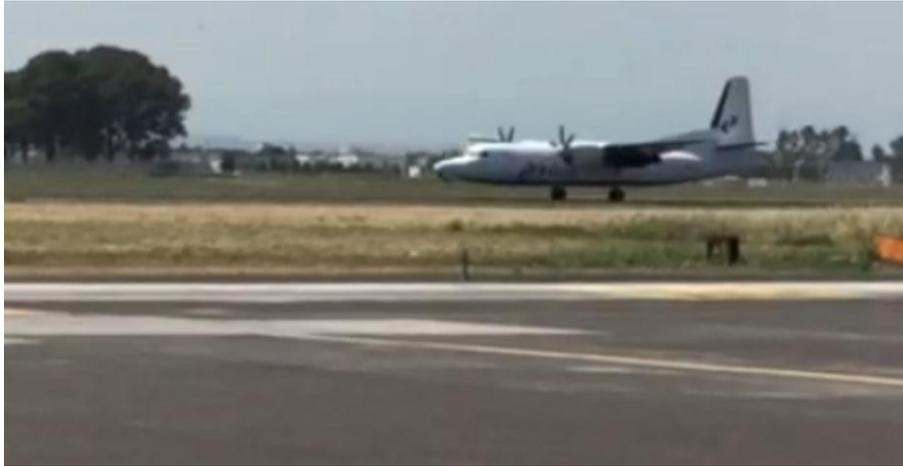
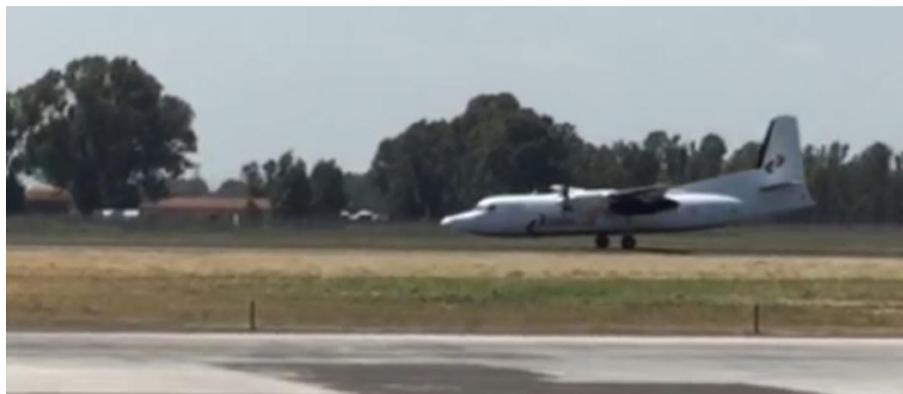
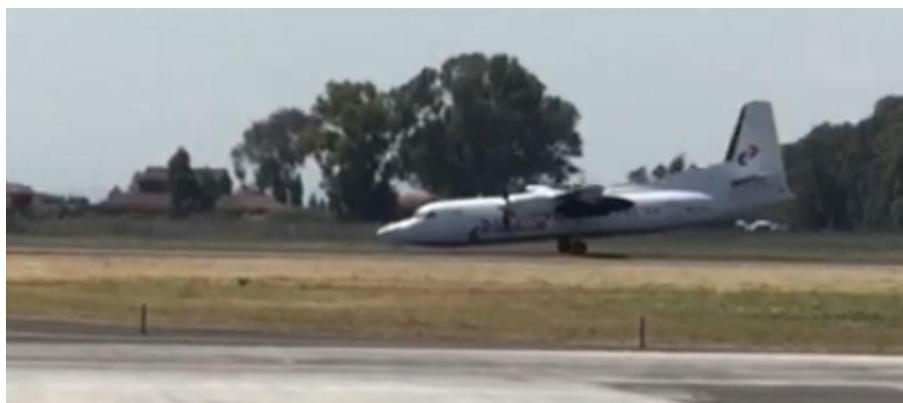
Landing took place at 09:34 hrs with the main gear properly extracted and locked, the nose gear in "up" position and the doors open.

The following is a sequence of pictures taken from a video of the accident, acquired by ANSV through the Catania airport operator, in which the aircraft is seen landing with the nose landing gear not extended and touching the ground only when it reached the speed necessary to sustain it in the absence of nose landing gear support.

Photos 1, 2 e 3: photographic sequence of the landing.

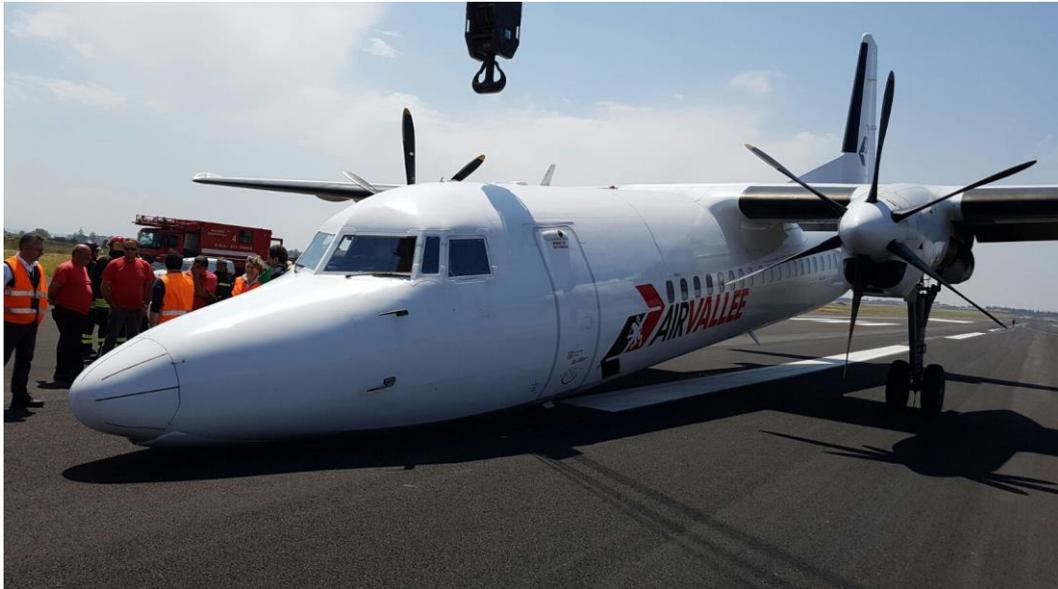
Photo 4: the aircraft in its final stop position on the runway.

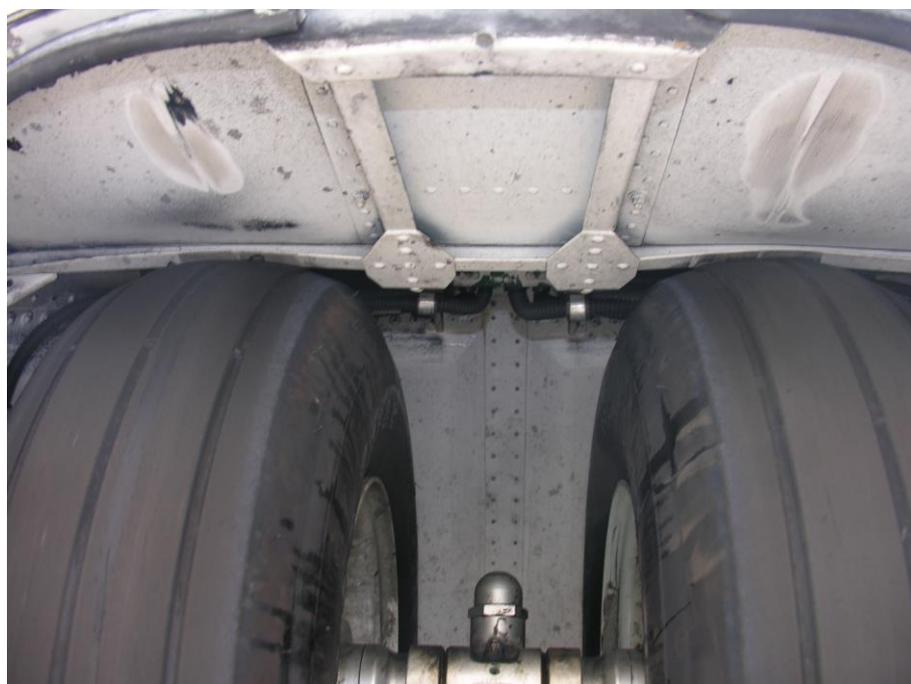
The doors of the nose landing gear compartment were both damaged near their inner edges.

Inside the nose landing gear compartment, there was an interference between the two tires and the front vertical panel of the nose landing gear compartment, partially deformed by the interference with the wheels as shown in the following picture

Photo 5: nose landing gear compartment.

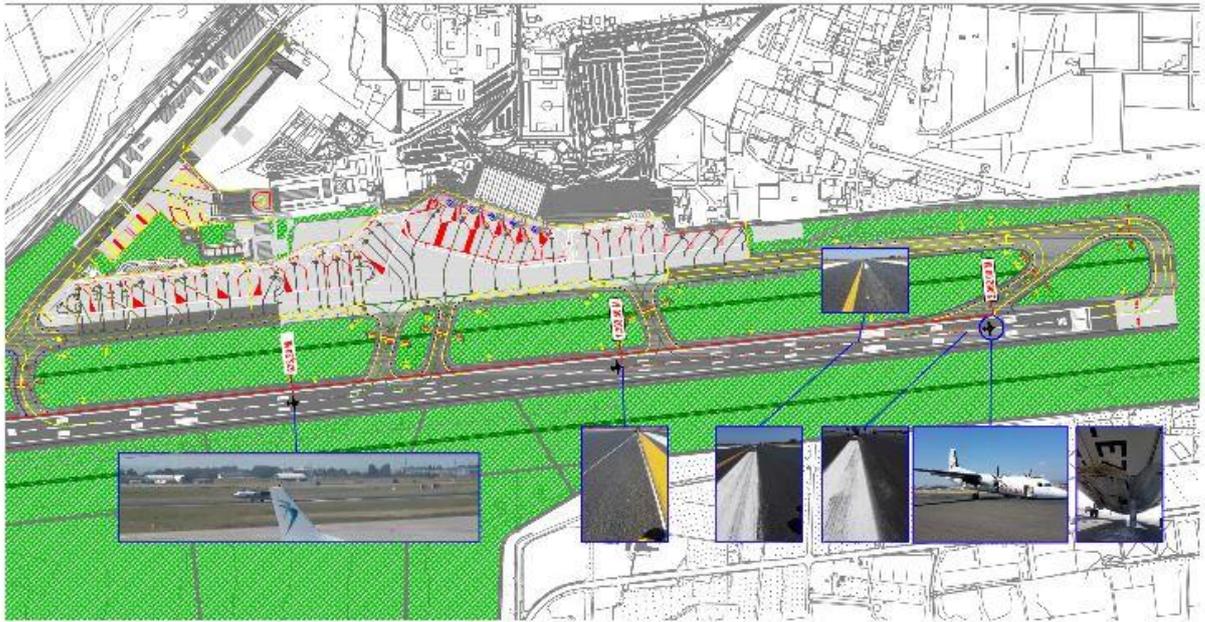
Figure 2: traces on runway.

The aircraft touched the ground with only its main gear at about 633 meters from the beginning of the runway and came to a complete stop after a distance of about 1430 meters: the front part of the fuselage of the aircraft crawled on the ground in the last 250 meters.

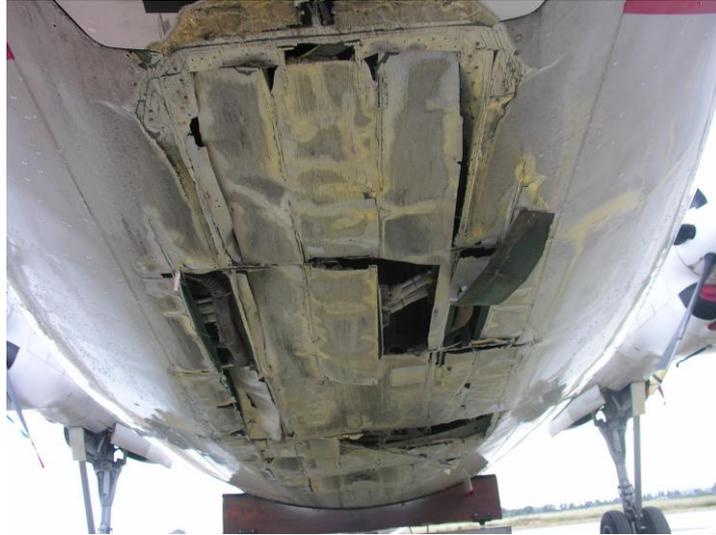
The aircraft was found damaged to the lower part of the fuselage, at the rear of the nose gear compartment (attachment A).

Photo 6: damages to the lower fuselage.

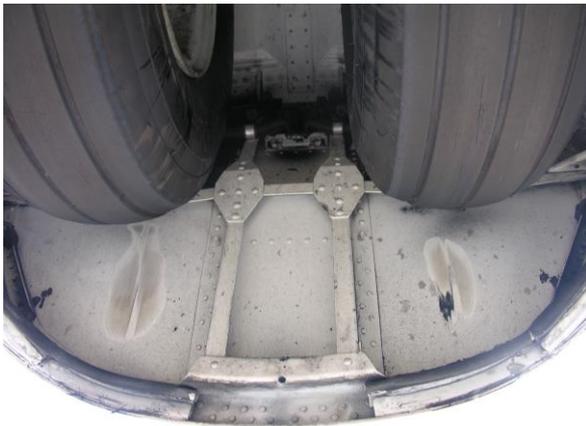
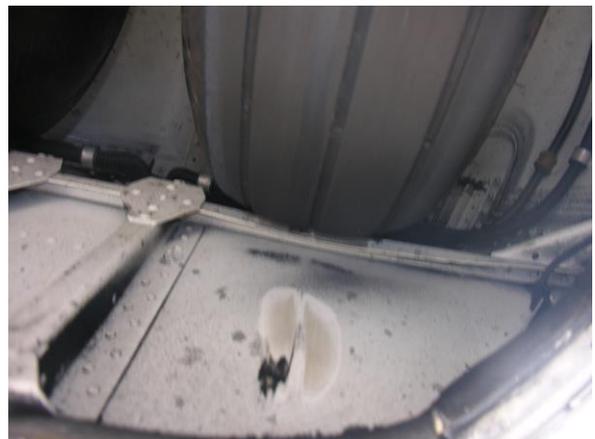
The doors of the nose landing gear compartment were both damaged near their inner edges. Inside the nose landing gear compartment, there was an interference between the two NLG tires and the front vertical panel of the NLG compartment, partially deformed by the interference with the wheels, as shown in the following pictures.

Photos 7 and 8: nose landing gear compartment.

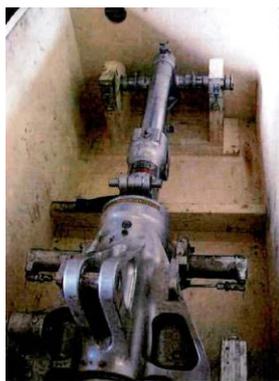
- In order to quantify the hyperextension of the shock absorber, the length of the shock absorber between the gland nut and the chrome plating of the sliding member was measured and found to be 422,3 mm; the same measurement was taken again after the correct reassembly of the upper stop of the sliding member and the locking cylinders (dowels), found to be 349,25 mm, thus leading to calculate the hyperextension of the shock absorber of 73,05 mm.

- The general condition of the NLG appeared normal, except for the position of the torque links and the sliding member (see following picture).

Photo 9: NLG in the containing box.

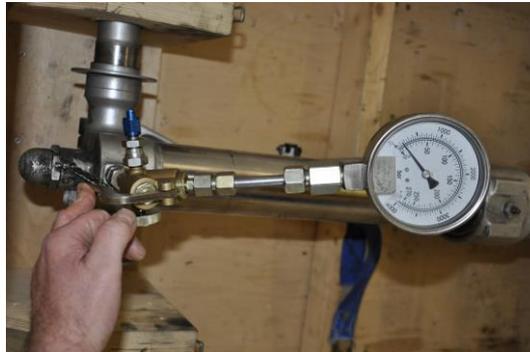
- With the component still inside the box, the nitrogen pressure was measured, using an analogue manometer: the measured pressure was 140 psi, lower than the expected value of 185-195 psi (as in the following picture).

Photo 10: nitrogen pressure measurement.

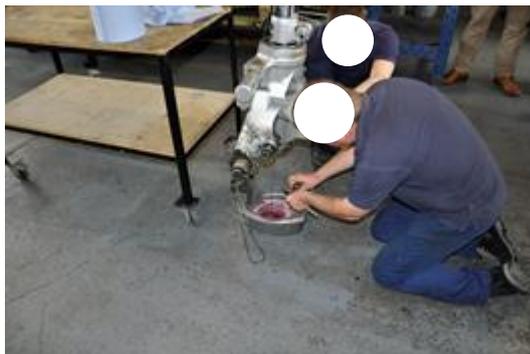
- The hydraulic fluid was drained from the shock absorber into a clean container; the amount of oil in the component was 2700 ml, 407 ml more than the expected volume of 2293 ml (see picture below).

Photo 11: hydraulic fluid draining.

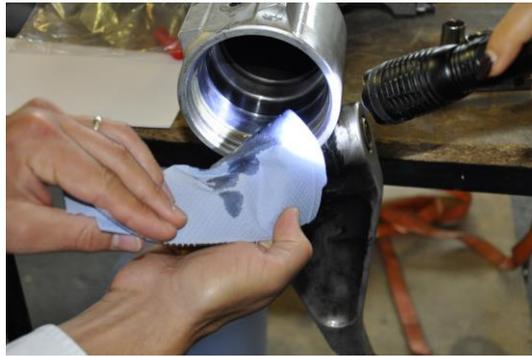
- The drained oil appeared clean, however a sample was taken for analysis, which subsequently ascertained that it was mineral oil, with an acceptable amount of water.
- The valve seat was found to be assembled with an incorrect orientation with respect to the applicable manuals.
- The Gland Nut was removed and a torque of 30-35 lb/ft was applied, well in excess of the 13.3-14.8 lb/ft tightening torque specified in the maintenance manual.
- The nut was removed to free the Sliding Member, an excessive play was immediately noticed, indicative of a probable separation of the upper bearing from the Sliding Member.
- After the removal of the Sliding Member from the Turning Tube, some metal fragments were collected and subsequently analyzed (see picture below).

Photo 12: metal particles.

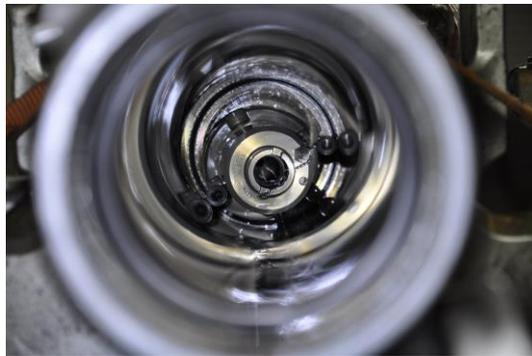
Photo 13: visual observation of the valve housing, piston and locking cylinders (dowels).

- Once these components were recovered, no breakage of the components was detected.
- Some marks were found on the valve seat orifice seats, indicative of an incorrect valve seat position during installation.

- There were some indentations on the surface of the sliding member, valve seat and bearing sleeve, indicative of the valve seat being installed in an improper orientation.

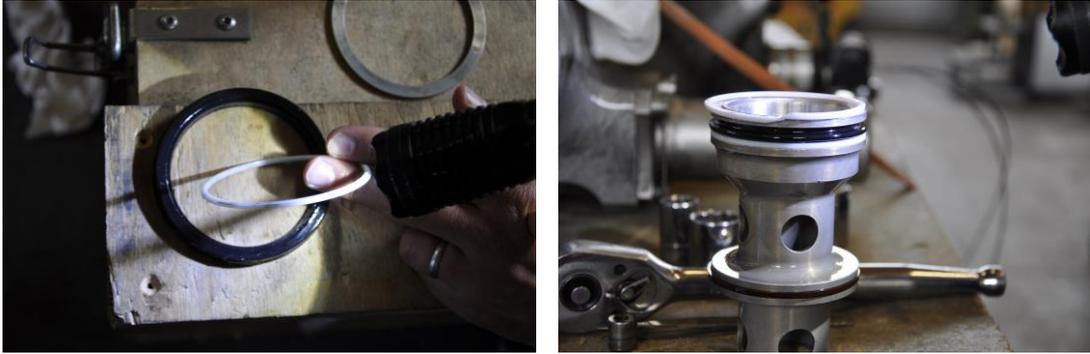
- The gasket assemblies (gland u-ring backing ring and heel sub-assy) were removed, as they had been installed with an improper orientation, as well as the piston backing rings, installed underneath (see pictures below).

Photos 14 and 15: seal improper installation.

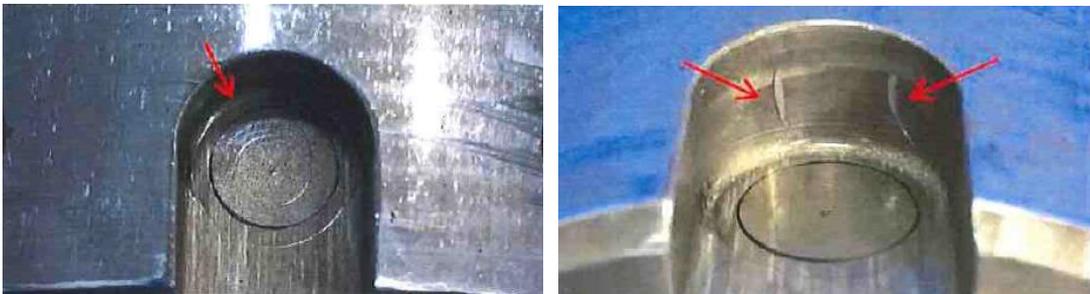
Investigation conducted at the manufacturer's laboratories revealed damage on the Valve Housing, as shown in the following pictures, which showed that the dowels had been installed in the Orifice Slots (U shaped) instead of the circular holes.

Photos 16 and 17: damages on the *valve housing*.

The findings of the investigation at SMITH Aerospace indicate that the hyperextension of the front landing gear was caused by the improper installation of the Sliding Member Valve Housing during the replacement of the internal Shock Absorber seals (Gland Seal and Separator Piston Seal).

Incorrect orientation resulting from the improper installation of the Valve Housing and the insertion of the dowels into the "U shaped" holes instead of the holes intended as their seat, allowed the dowels to fall through the Sliding Member, causing a loss of the upper stop of the Shock Absorber.

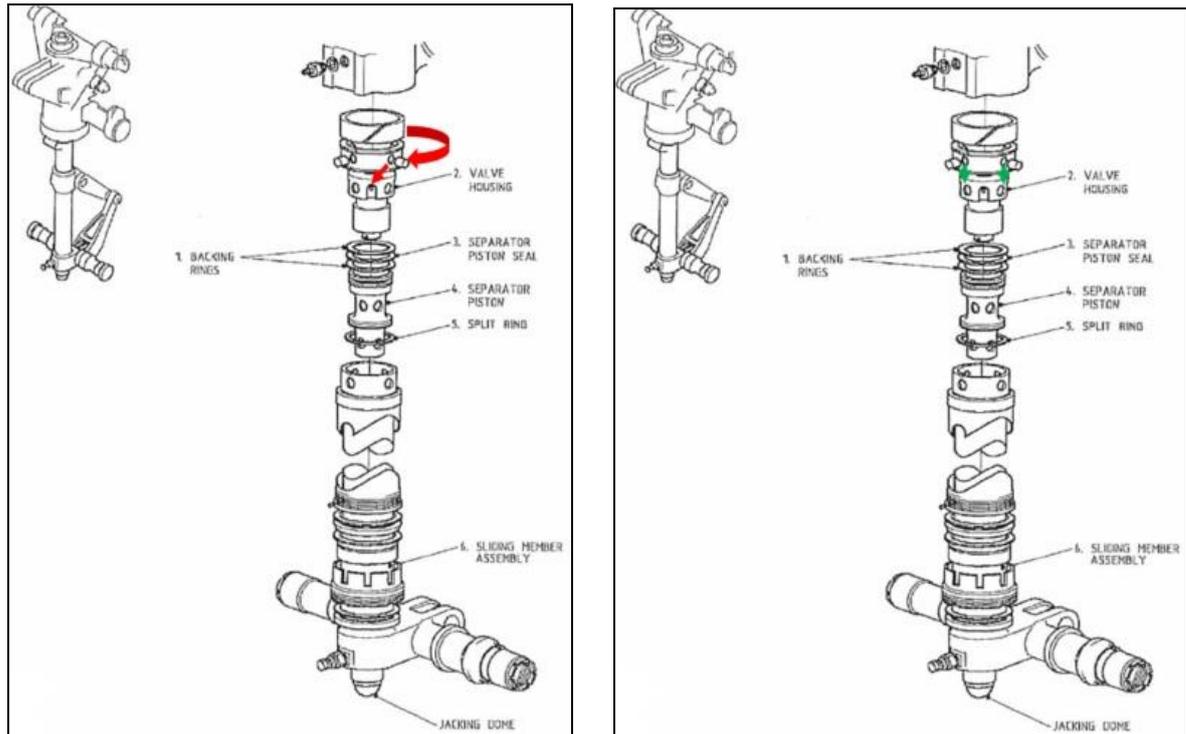
In the first of the following pictures, the wrong orientation of the Valve Housing is shown (red curved arrow) and the consequent wrong installation of the dowels in the "U shaped" holes (red arrow).

The second image shows the correct installation of the dowels.

Figure 6 and 7: improper (left) and proper (right) installation of the *valve housing and dowels*.

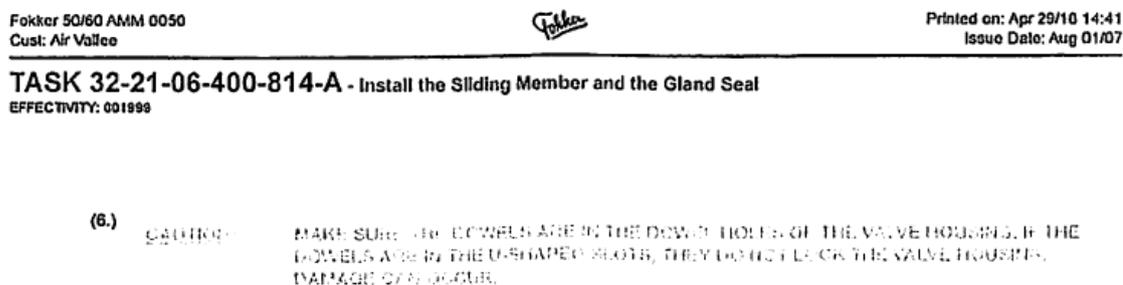
In case the procedures available to the maintenance personnel had been printed in black and white (as it would emerge from the testimonies), the visibility of the "CAUTION" in amber color would have been much less visible, as can be seen from the following picture,

Figure 11: "CAUTION" in amber colour, printed in black and white, present in the TASK 32-21-06-400-814-A.

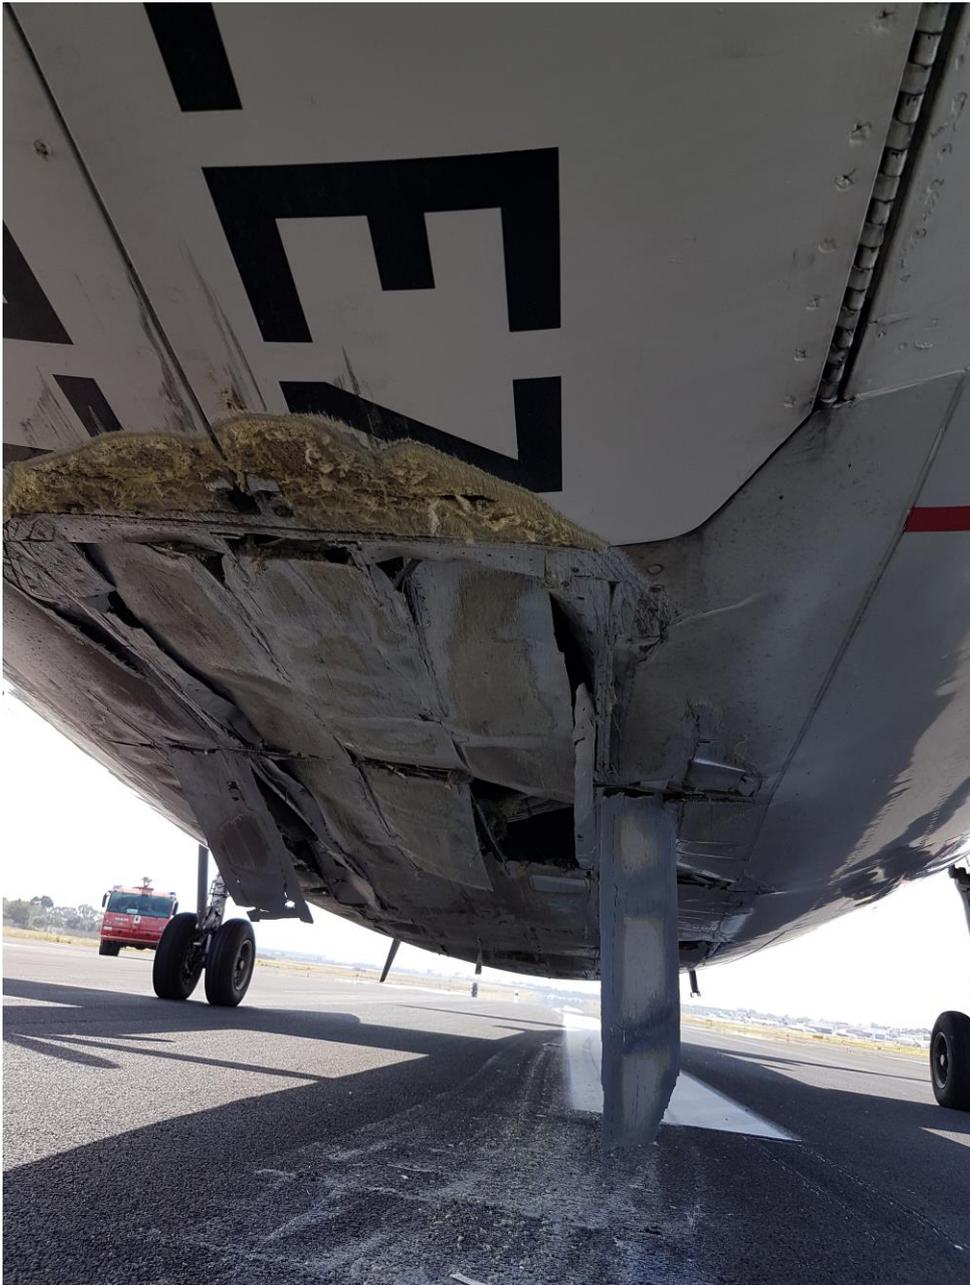
Photo 3: creep damage to the antero-inferior part of the fuselage.

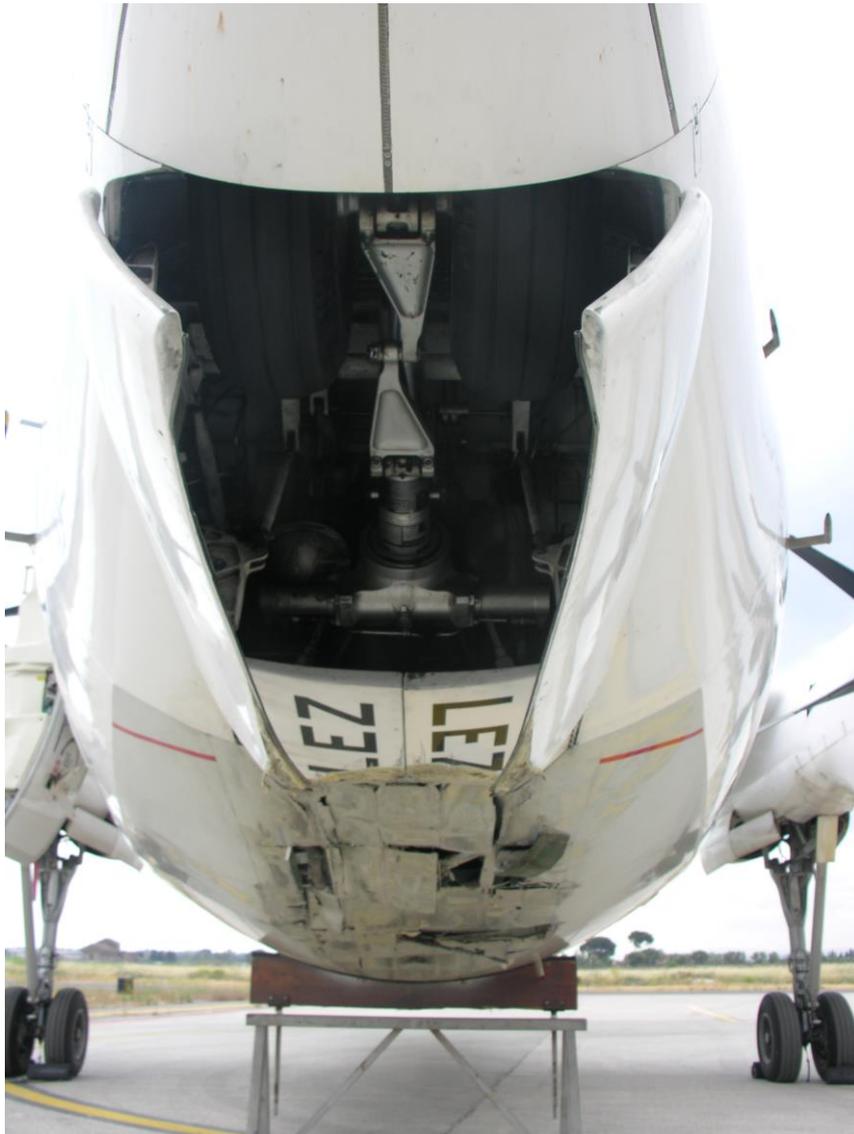
Photo 4: position of the NLG after the event (hyperextended).
