# **INVESTIGATION REPORT**

**SERIOUS INCIDENT  
involving the aircraft  
B737-8200, registration EI-IGI,  
at Caravaggio Airport (Orio al Serio – Bergamo),  
1<sup>st</sup> October 2024**

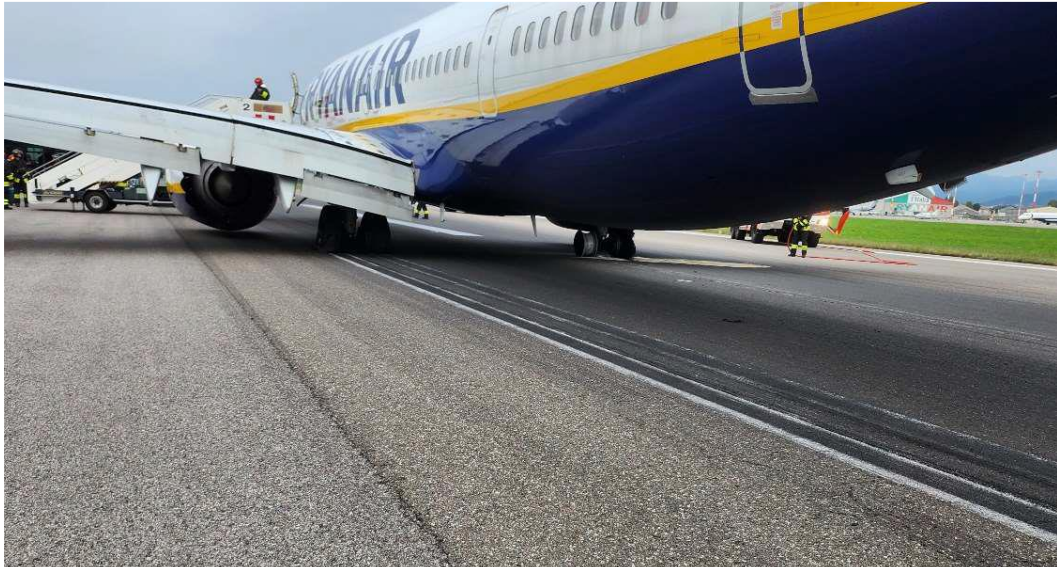
The 4 main landing gear tires had burst, and wheels 1, 2, and 3 showed significant damage caused by friction against the runway, most severe on wheel 1 and less so on the other two. Additional damage was observed on the main landing gear, the actuators for the right-wing control surfaces, the control surfaces themselves (immediately aft of the landing gear), and the right side of the fuselage.

Photo 1 : close-up of wheel damage – rear view (source: SACBO).

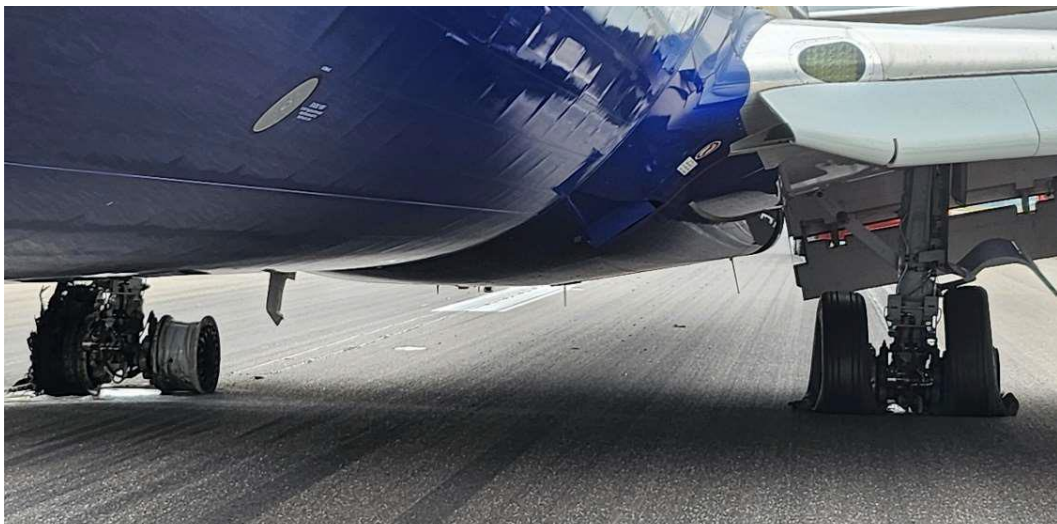
Photo 2 - Detail of wheel damage - front view (source: SACBO).

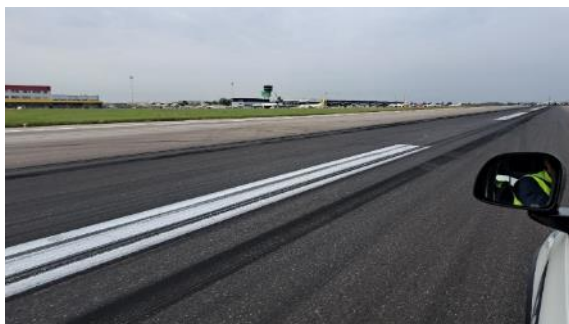
Photo 4 - skid marks on the runway

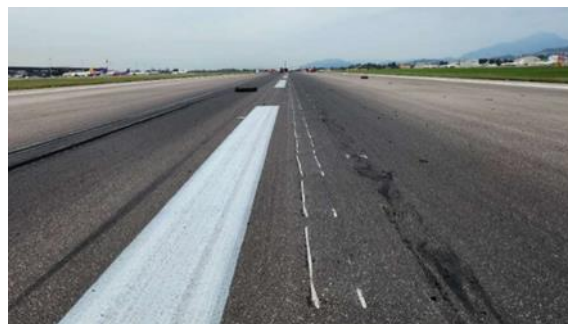
Photo 5: runway damage and debris on the runway

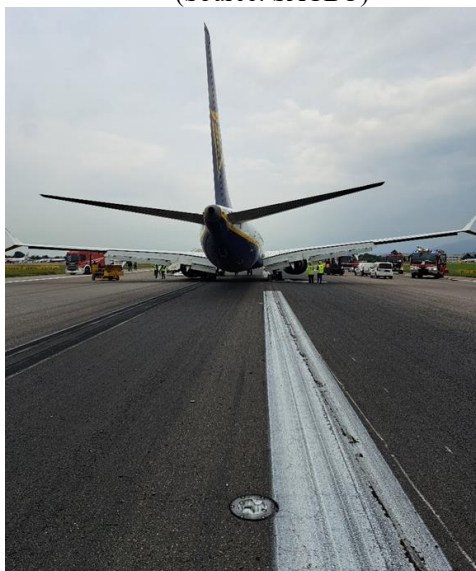
Photo 6 - area of the runway, near the aircraft, affected by damage and debris (Source: SACBO)

The detachment of two tyres from the right-hand landing gear is evident. The debris appears to be distributed as shown in the illustration below.

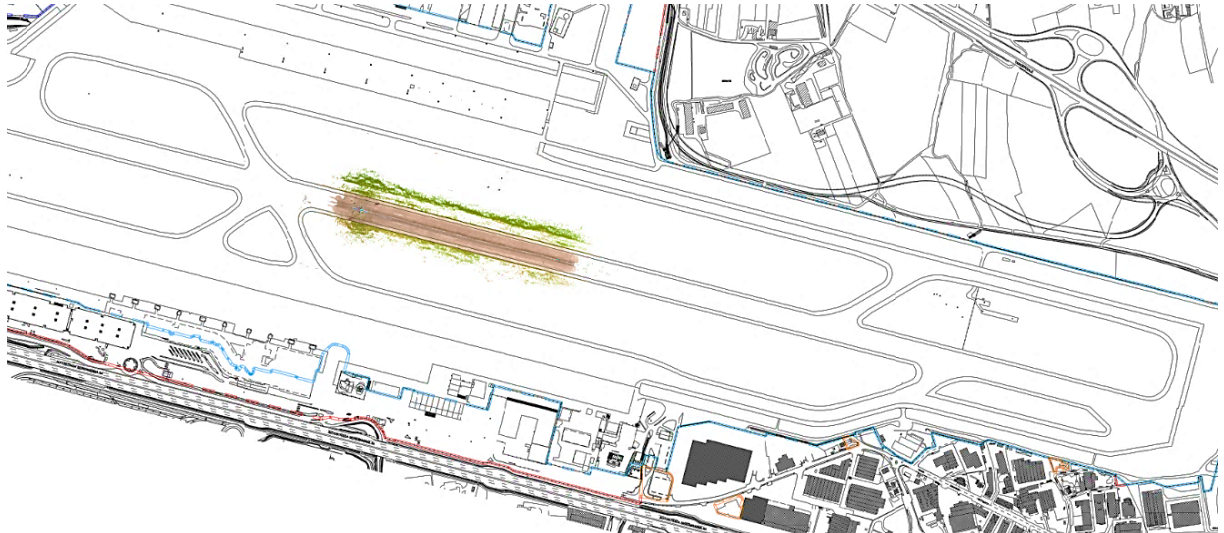
Figure15 – Illustration of the distribution of debris on the runway (Source: SACBO)

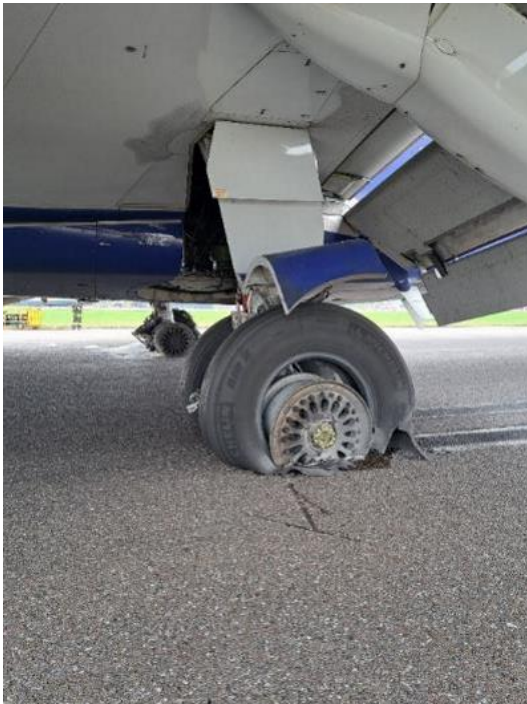
Photo 7 - photo of the MLG taken from the left side of the aircraft

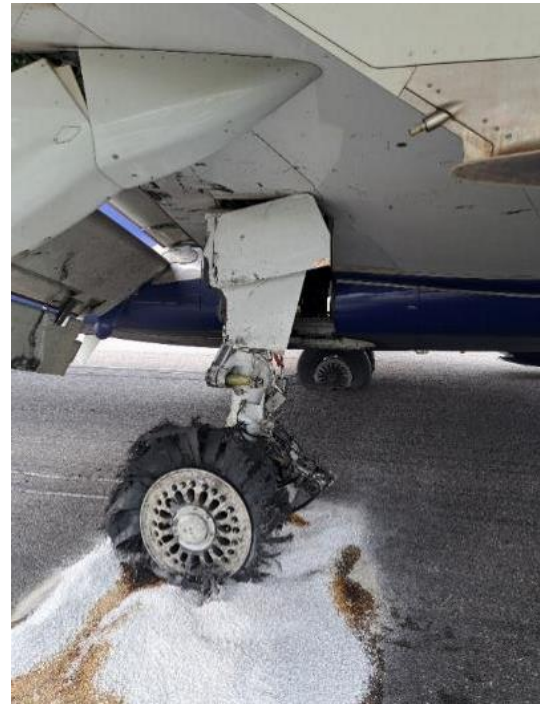
Photo 8 - photo of the MLG taken from the right side of the aircraft

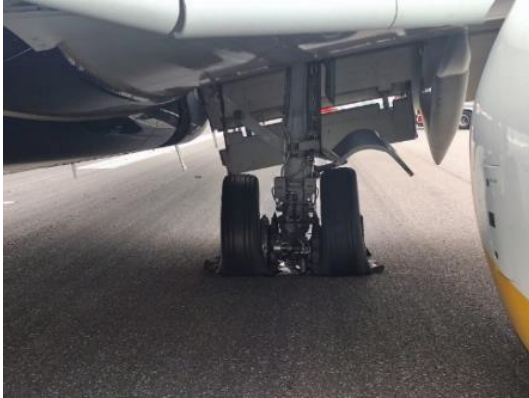
Photo 9 – Front view of left MLG

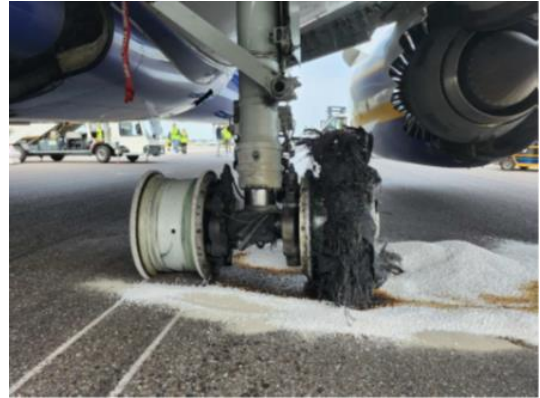
Photo 10 - Rear view of the right MLG

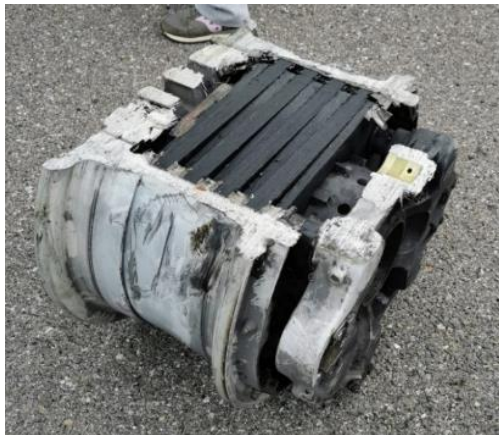
The brake assemblies on wheels #1 and #2 were locked in the retracted position; the burst tyres were still in place, the wheels showed evidence of considerable wear due to friction on the tarmac, more so on wheel #1

Foto 31 - Detail of brake and wheel #1

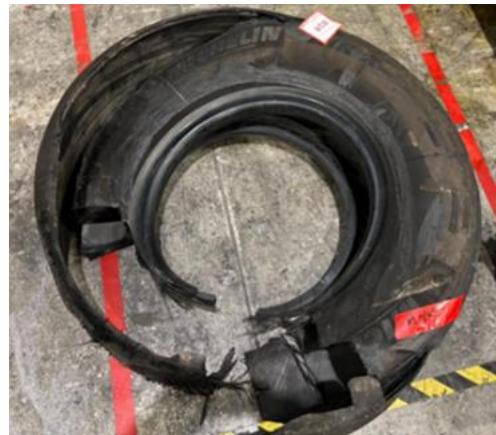
Photo 12 - Detail of the tyre #1

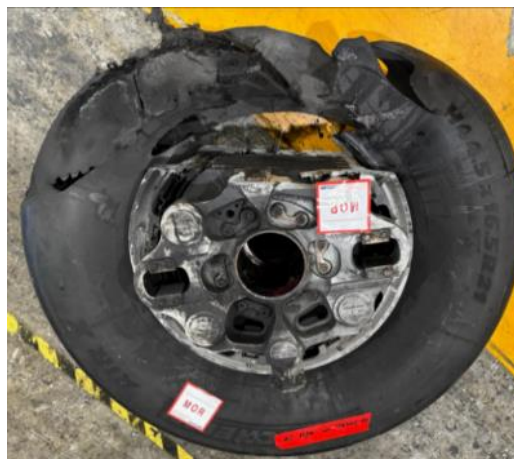
Photo4 - Detail of wheel and tyre #2

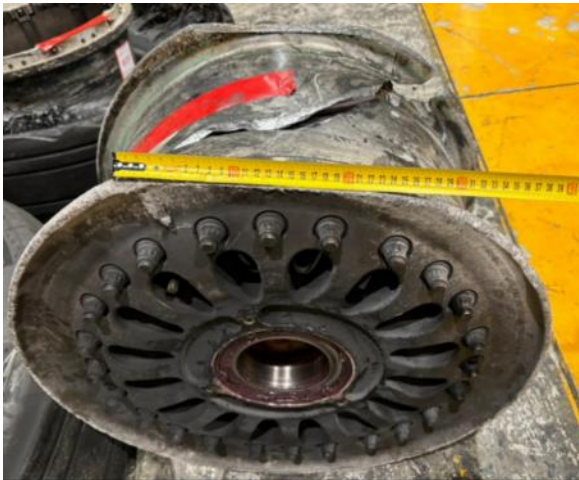
The tyres on wheels #3 and 4 had burst. In particular, the tyre on wheel #3 had been torn off and the wheel showed signs of friction with the tarmac. Wheel #4 was still able to rotate.

Photo 6 - Detail of the wheel #3

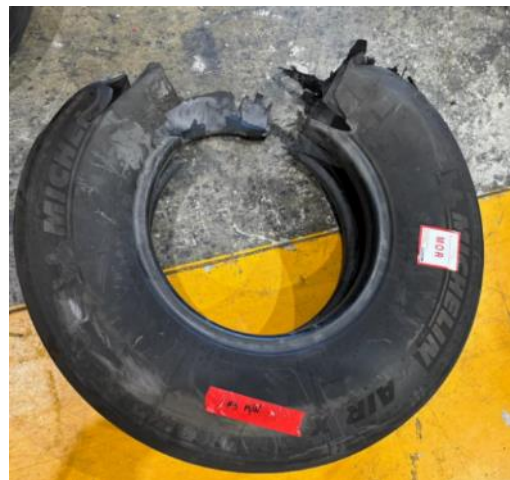
Photo 55 - Tyre #3

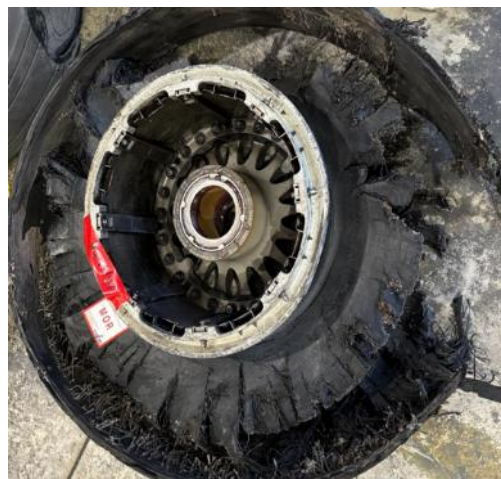
Photo 76 - Detail of wheel with tyre #4

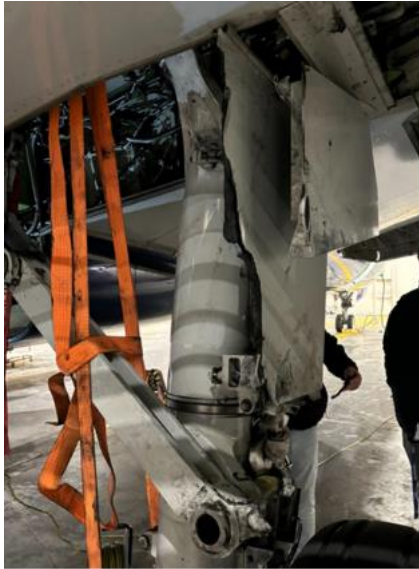
Regarding the structure of the right MLG, a rupture of the panel and the door linkage was found, along with damage to the 'air-to-ground' sensor. Detailed photos follow.

Photo 17: Structure, panels, linkages of the right MLG

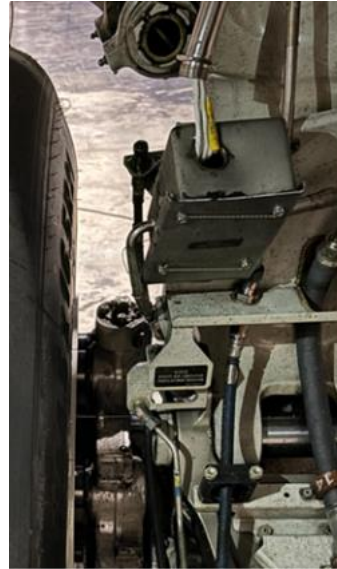
Photo 18 - air-ground sensor of the right MLG

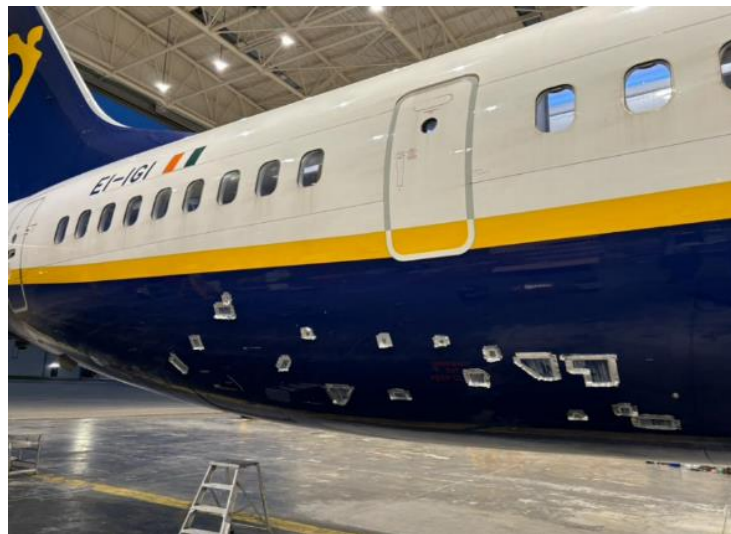
Numerous damages were found on the rear right section of the fuselage.

Photo 19 - Detail of damages to the right side of the fuselage

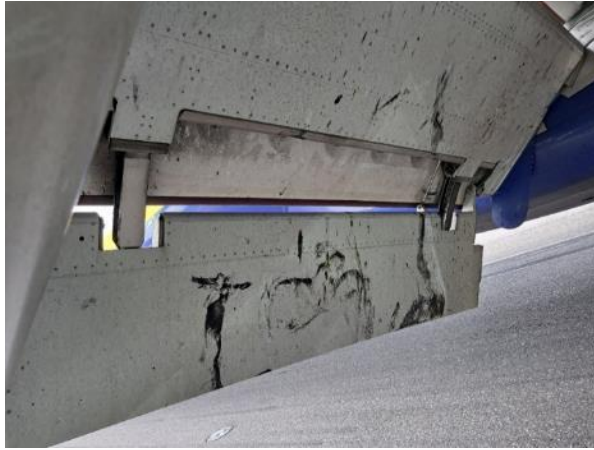
Damage was found to the structures of the right wing. In particular, the right flap panels and their linkages were affected.

Photo 20 - Detail of damage to the right-hand 'inner flap'

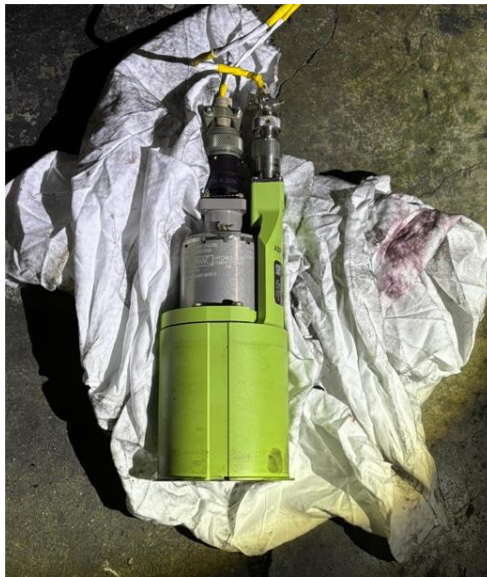
Following the serious incident, transducer no. 3 was removed and sent to the manufacturer to identify the causes of its failure. It was initially inspected and released for return to service. However, the repair carried out was reviewed and deemed unsatisfactory, as no fault was found with the unit, therefore, it was decided to send it back to the manufacturer for overhaul, which, again, did not identified any fault.

Following the incident, the four sensors were removed; trasducer #3, shown in the photo below, was the one found to be faulty following the braking system tests and troubleshootings carried out by the maintenance team.

Photo 21 - Wheel transducer #3

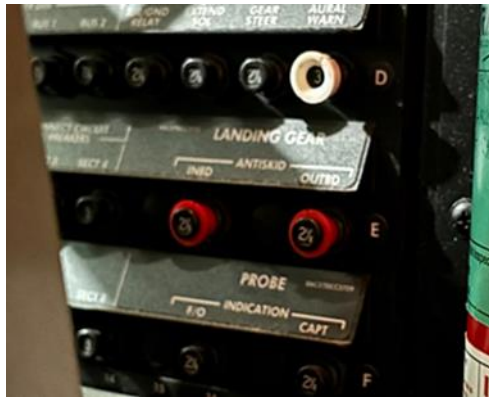
The circuit breakers relating to the LANDING GEAR – ANTISKID, both INBOARD and OUTBOARD (position P6-3), were found to have been removed and protected with a ‘collar’; furthermore, the label had been put on the relevant panel of the antiskid system, as shown in the following picture.

Photo 22 - detail of the removal and protection, using a 'collar', of the ANTISKID switches (INBOARD and OUTBOARD)

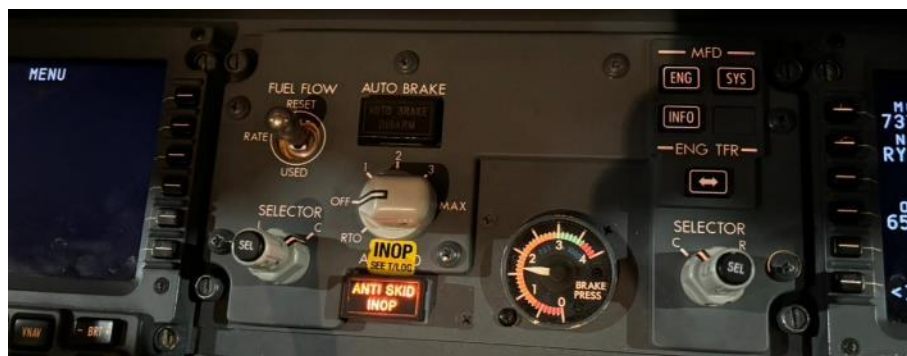
As previously noted, during the site inspection it was found that only the label relating to the anti-skid system had been affixed. Further information regarding the affixing of labels (PLACARD) is provided below, in the context of the detailed discussion of certain specific maintenance procedures;

Photo 238 - Antiskid INOP warning light and the yellow label indicating the system is inoperative

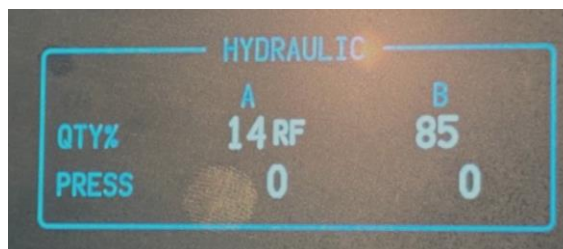
System A indicated 14RF (RF: Refill) and system B indicated 85.

Photo 24 - Hydraulic system indications

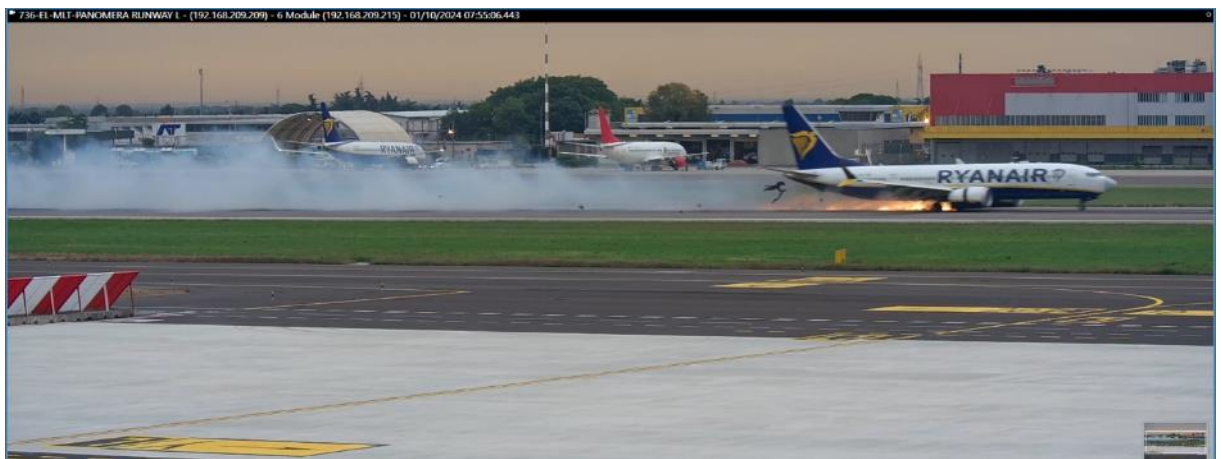
The aircraft continues its run with the MLG wheels locked, accompanied by fire and detachment of parts:
