# **FINAL REPORT**

## **ACCIDENT**

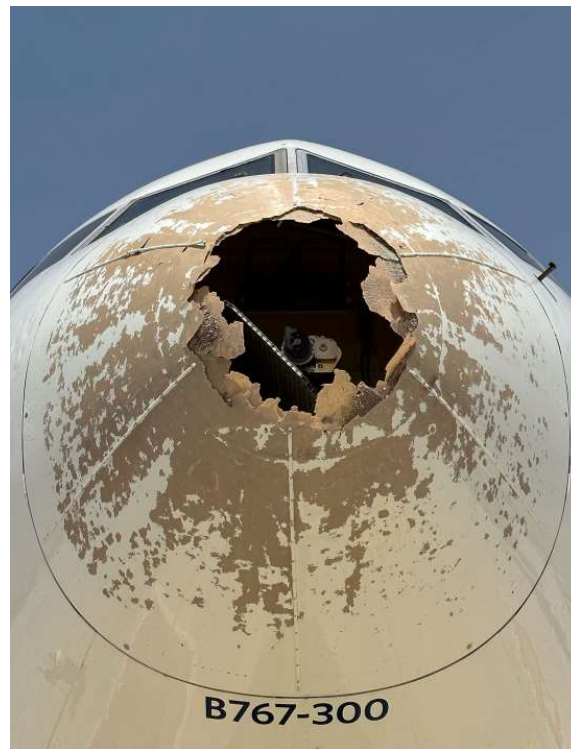
Figure 2: damage to the radome.

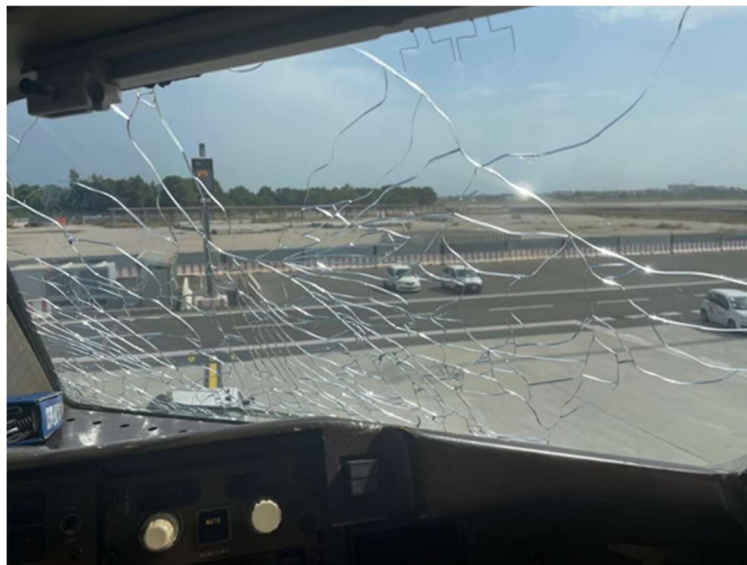
Figure 3: damage to the First officer windscreen.

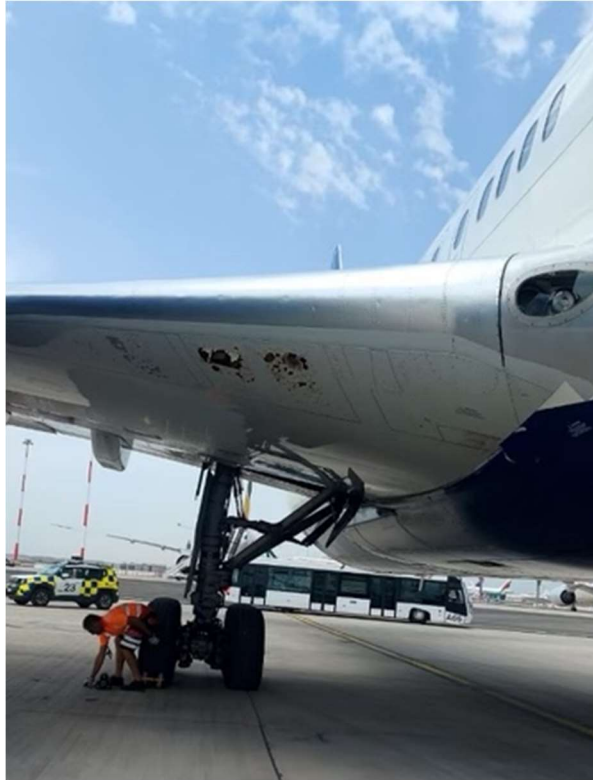
Figure 4: damage to right wing panels.

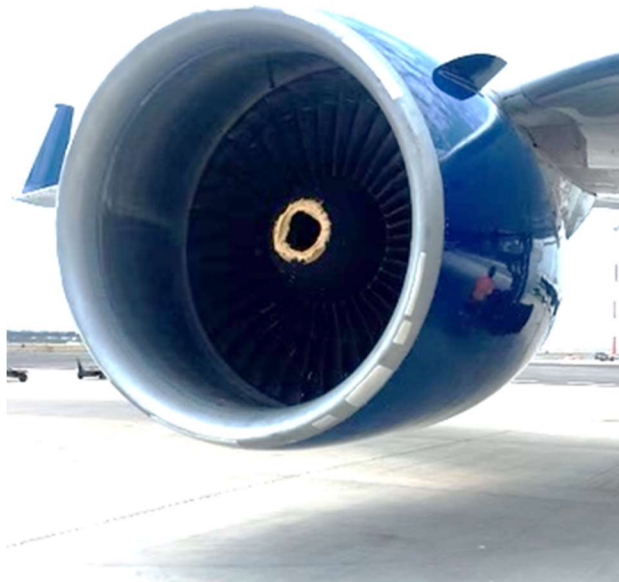
Figure 5: damage to right engine nozzle cone.

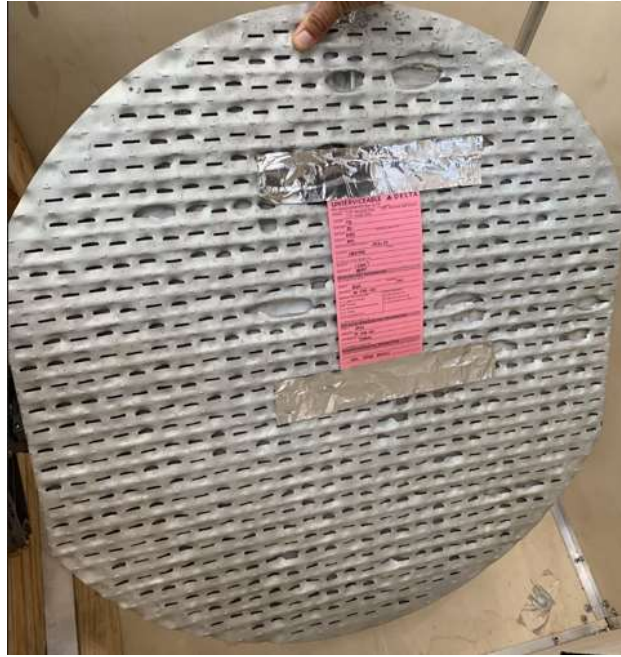
Figure 6: weather radar damaged.
