# **PRELIMINARY REPORT**

## **SERIOUS INCIDENT**

**Airbus A320-214 registration marks CN-NML,  
Catania Fontanarossa International Airport (Italy),  
20<sup>th</sup> of September 2025**

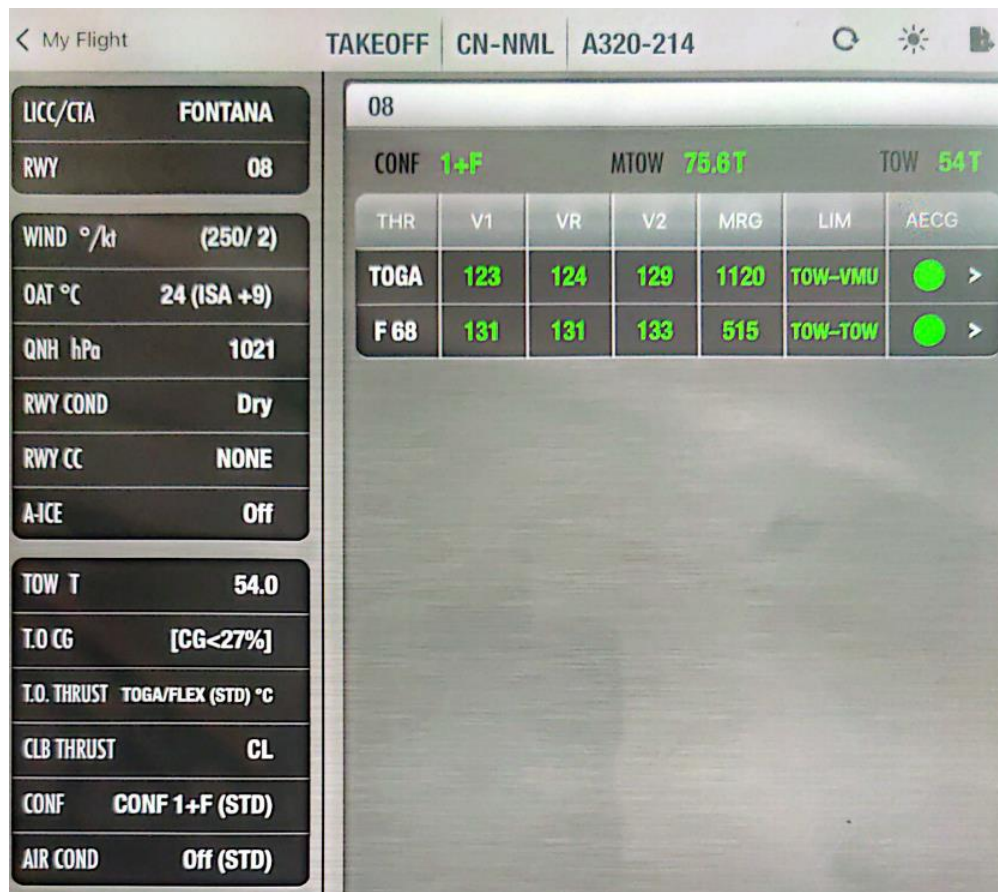
Post flight computation made with the *Flysmart* (Figure 1) EFB software led to the following TO speeds:

Figure 1: *flysmart* TO speed computation.

Based on the preliminary information available to the ANSV, these were not inserted in the MCDU. Therefore, the following information from the FCOM is considered important in order to understand the event.
