FINAL REPORT

**ACCIDENT
occurred to
FOKKER F27 MK50
registration marks SE-LEZ,
at Catania Airport,
April 30, 2016**

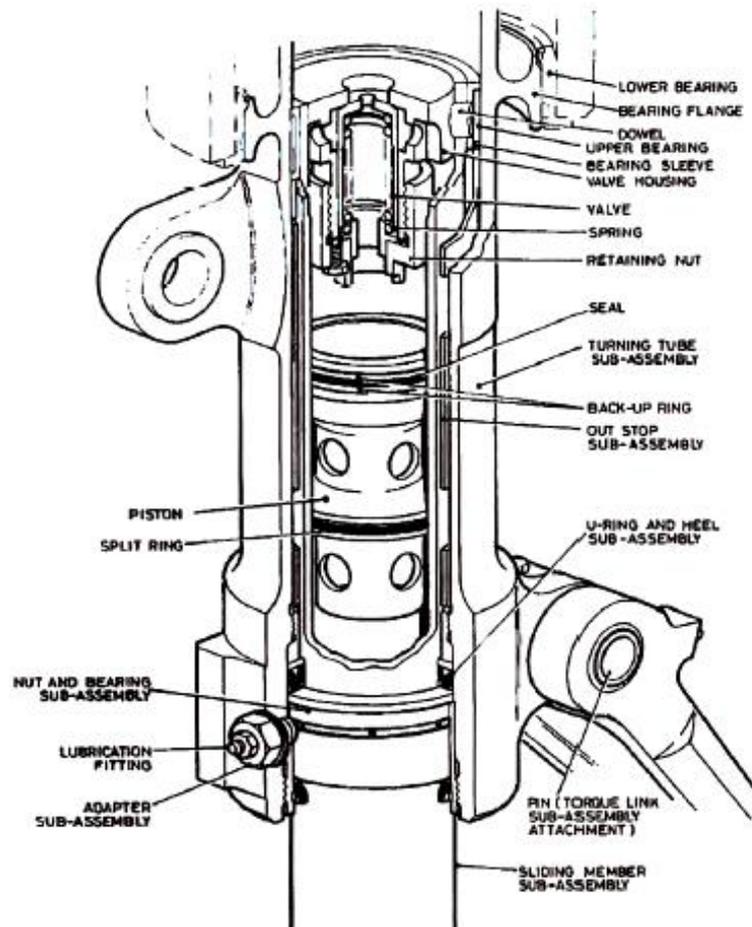
The shock absorber includes an upper part (Turning Tube in the following figure 1), inside which a Sliding Member slides, whose movement is supported by a bearing.

A bearing and its flanged sleeve are attached to the top of the Sliding Member.

4 locking cylinders (Dowel in the figure 1) lock the valve seat and the bearing sleeve to the Sliding Member.

Figure 1: sectional view of the NLG damper.

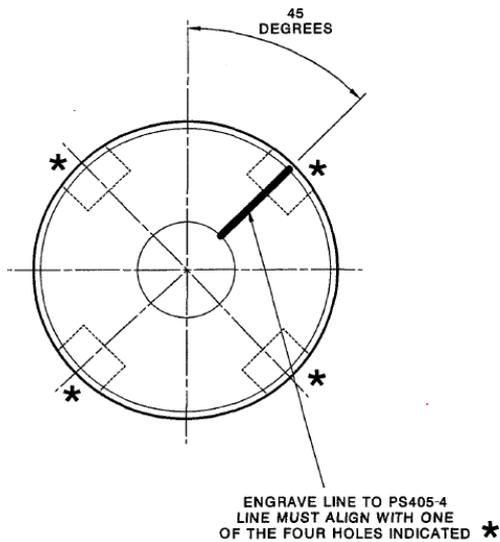
In January 1996 Safran (Messier Dowty Ltd) issued the SB F50-32-60, which modified the CMM with the instruction to etch reference lines on the valve housing and sliding member to ensure their correct alignment during installation, as shown in the following figures.

Figure 3: engrave line.

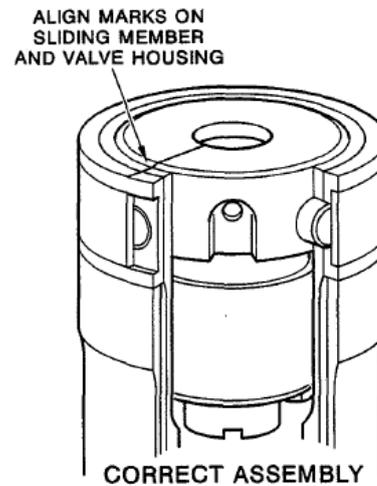
- It was noted that the orienting line made on the bearing sleeve was oriented in the opposite direction to the line made on the sliding member and the valve housing.

Figure 4: align marks between sliding member and valve housing.

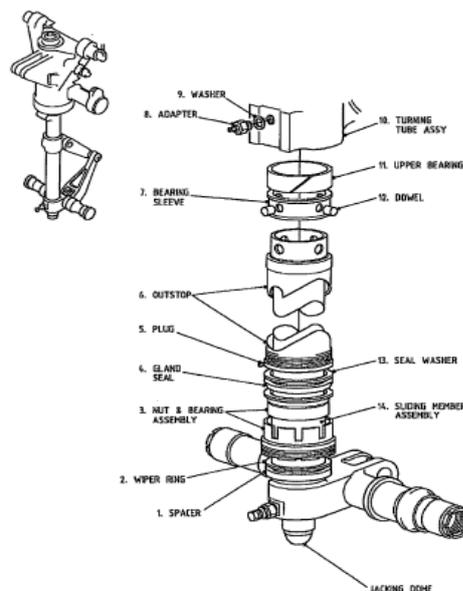
Sliding Member - Removal
Figure 32-21-06-000-014-A00

Figure 5: TASK 32-21-06-400-814-A.

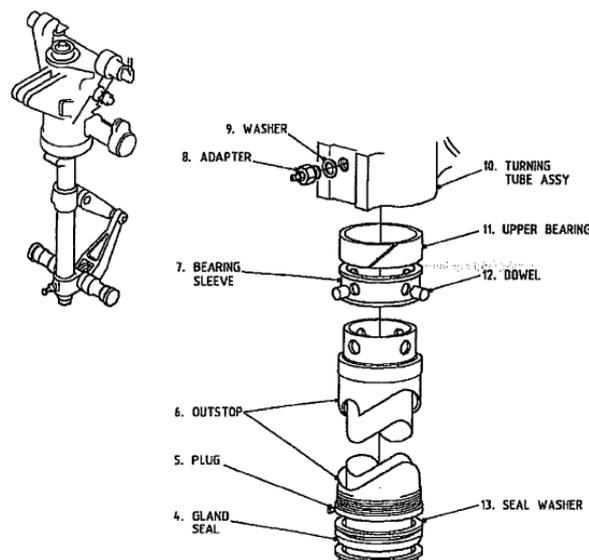
In the procedure that follows, the "CAUTION" requires to align the holes of the 4 dowels of the valve housing with the holes on the bearing sleeve and to insert the dowels. In the figure to which the procedure refers, a section of which is shown below, the valve housing is not shown.

Figure 8: excerpt from TASK 32-21-06-400-814-A.

It should be noted that in both of the above procedures there is no request to refer to the lines inserted with SB F50-32-60 and made on the valve housing and sliding member to ensure their correct orientation, as instead indicated in SB F50-32-60.

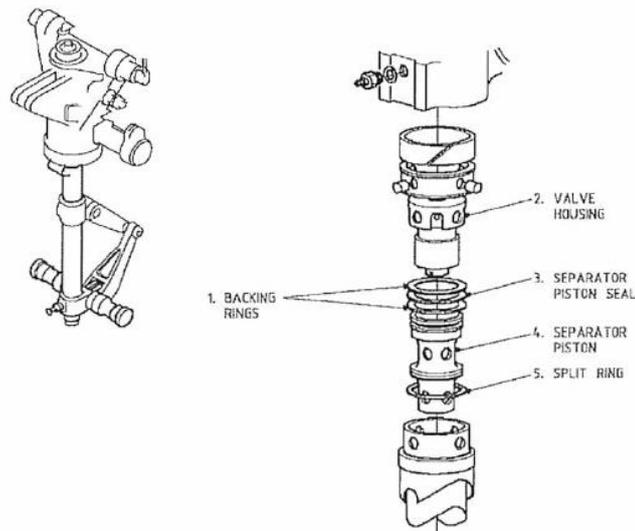
There is also a figure in that procedure that, unlike the figure in TASK 32-21-06-400-814-A, clearly shows the valve housing.

Figura 10: highlighting, in TASK 32-21-06-400-824-A, the valve housing.

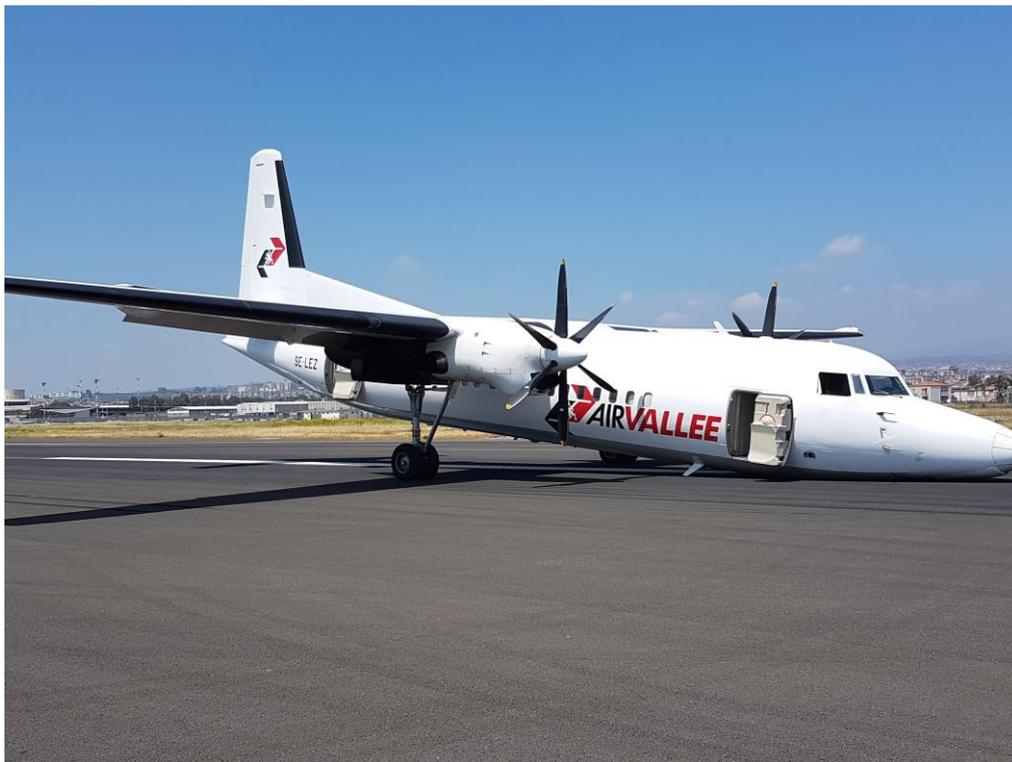
Photo 1: position of the aircraft immediately after the event, prior to removal from the runway.

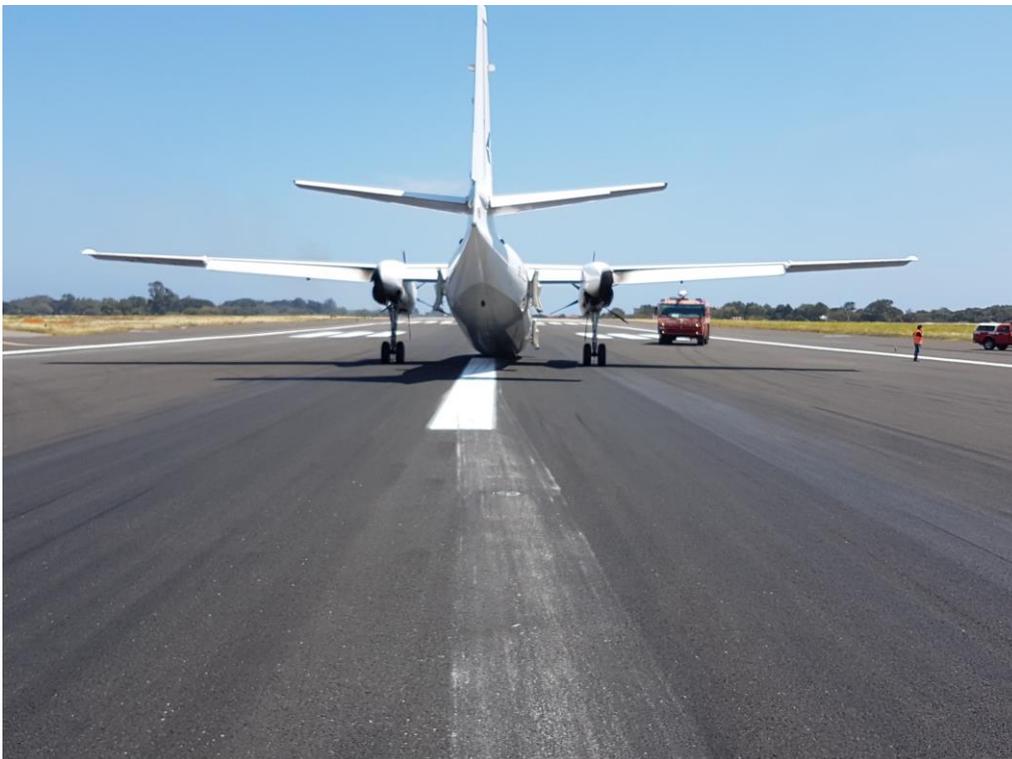
Photo 2: aircraft final position on the accident site, along the runway axis.
