# **INVESTIGATION REPORT**

**SERIOUS INCIDENT  
involving the aircraft  
B737-8200, registration EI-IGI,  
at Caravaggio Airport (Orio al Serio – Bergamo),  
1<sup>st</sup> October 2024**

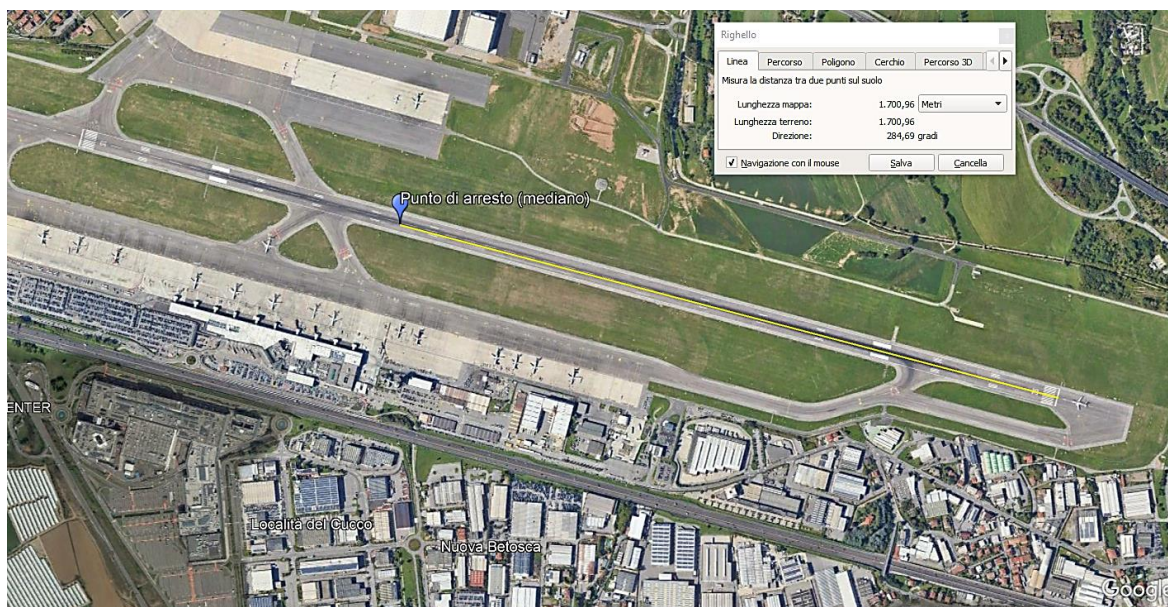
The aircraft came to a halt on RWY28, approximately 1700 m from THR28, at the point with coordinates 45°40'06.982" N 9°42'09.859" E.

Surveys on the runway were carried out by the airport operator, who then undertook repairs to the damaged asphalt surface.

Image1 : aircraft stopping point on the runway and distance from the threshold (Source: SACBO)

Once the repairs were completed, the runway was reopened at 17:26, to allow sufficient time for the repairs to set.

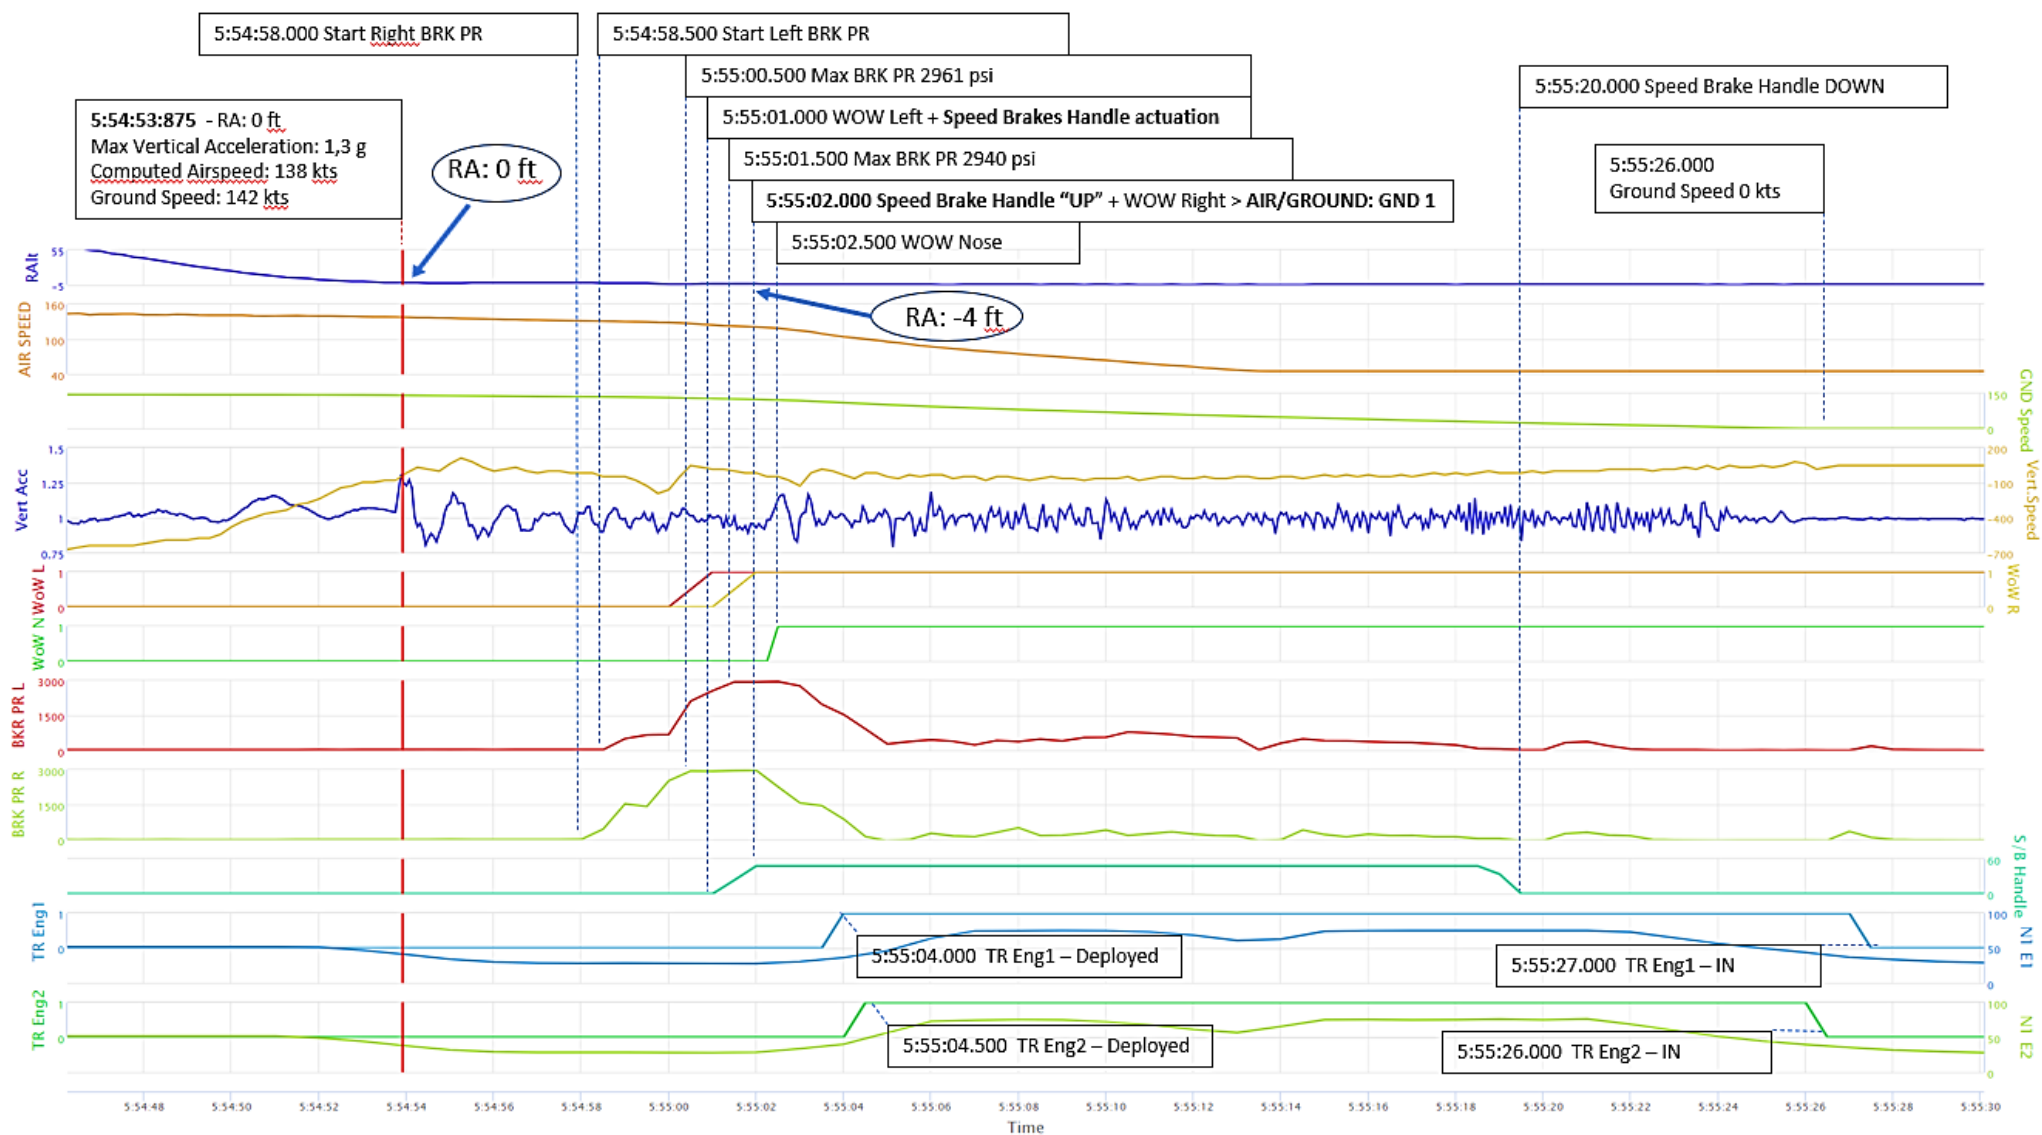
Figure 84 - timeline of events from the final approach to the stop on the runway (FDR data, processed by FAS)

At 5:54:53.875, with radalt at 0 ft and maximum vertical acceleration of 1.3 g, the first contact with the runway likely occurred, with a KIAS of 138 kt, a GS of 142 kt and a VS of 100 ft/min. At this time, neither the AIR/GROUND signal nor any of the WOW sensors had yet been activated.

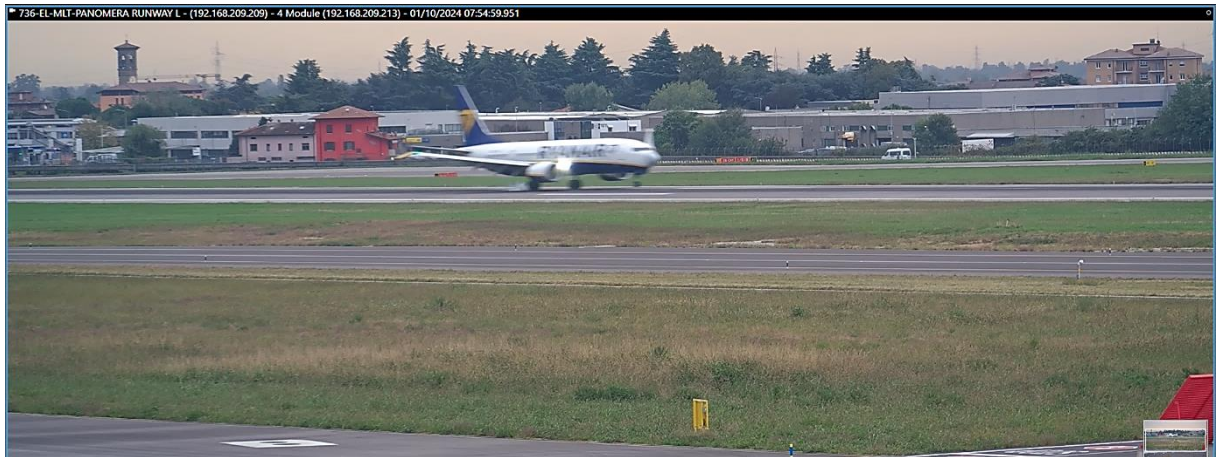
The first image shows the right brakes being applied:

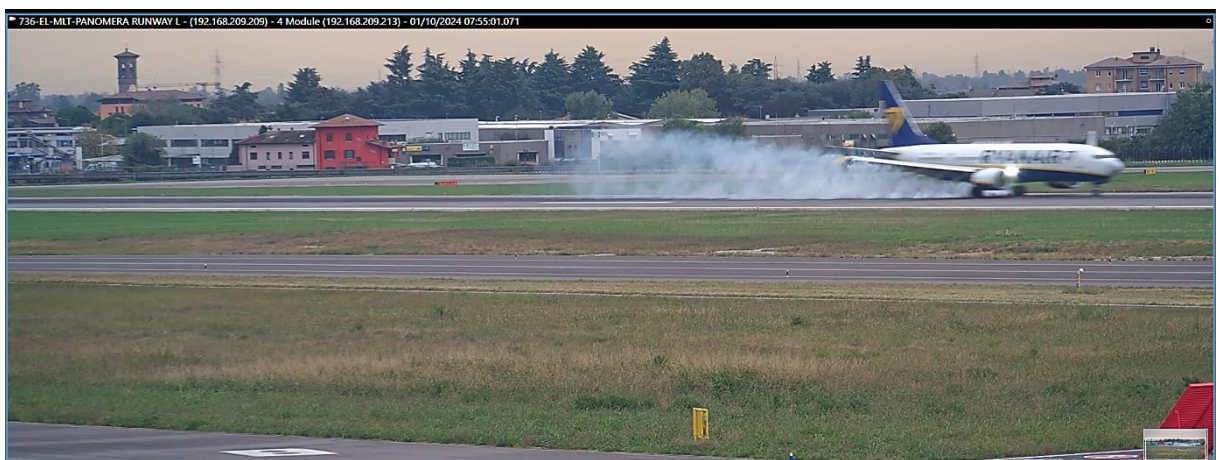
the second shows the left brakes also being applied:

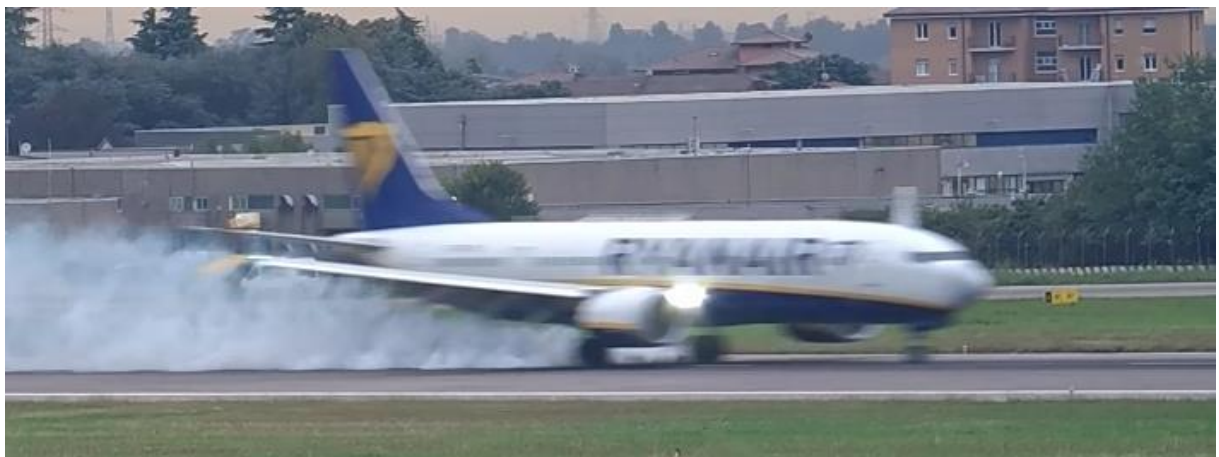
From the next image (enlarged), the speed brakes/spoilers have not yet been deployed:

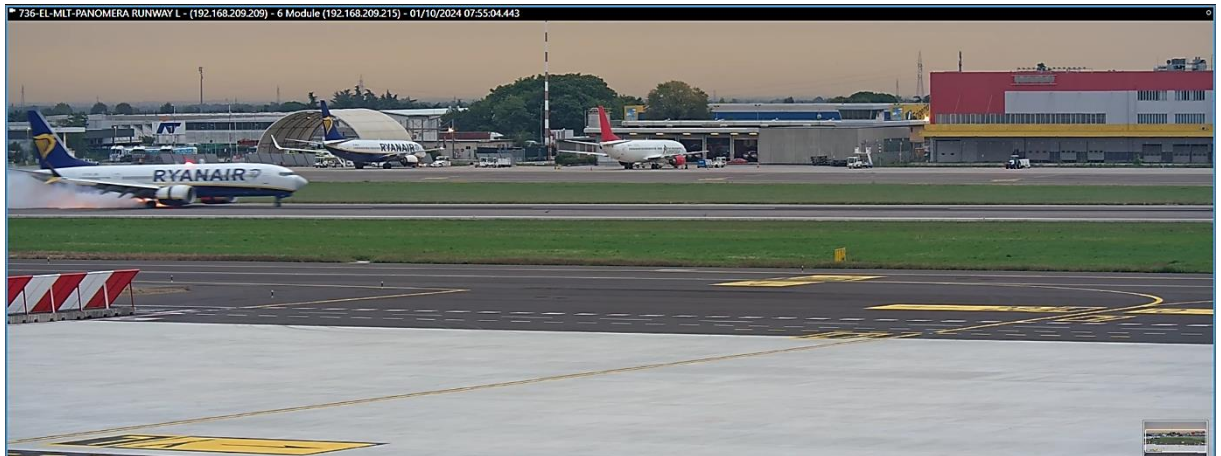
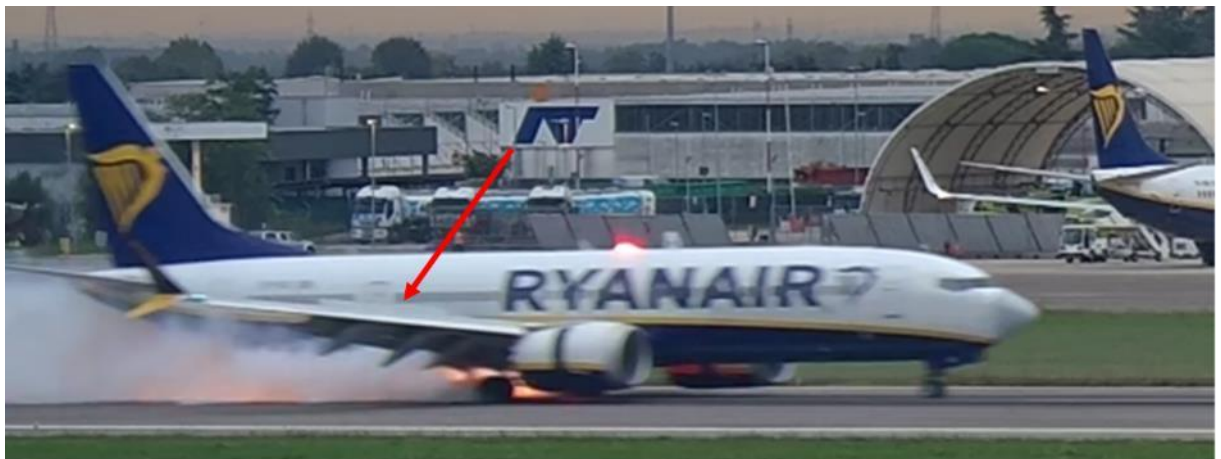
The next two images show that the speed brakes/spoilers have been deployed; according to the FDR data, this occurred when the WOW occurred on the MLG and the NLG:
